### The Bangkok Earthquake and What we learned from it

### Pennung Warnitchai

Professor of Structural Engineering Asian Institute of Technology (AIT)

# M 7.7 - 2025 Mandalay, Burma (Myanmar) Earthquake

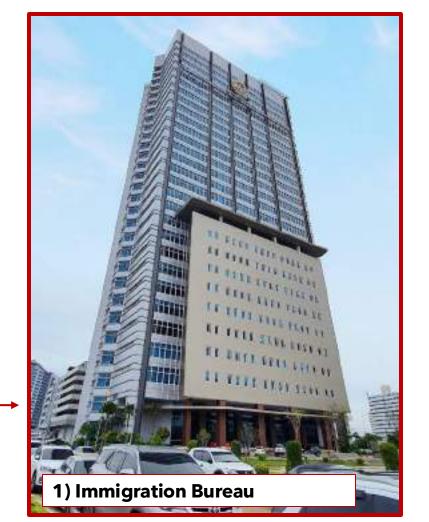
Shear wall, elevator shaft, and fire escape stairs on the 3rd and 4th floors were damaged.

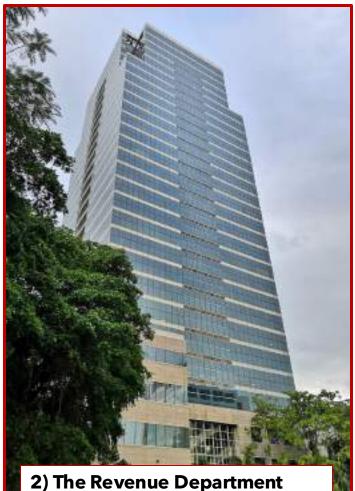
Serious damage on columns from 5<sup>th</sup> to 27<sup>th</sup> floor, along with cracks in the walls.

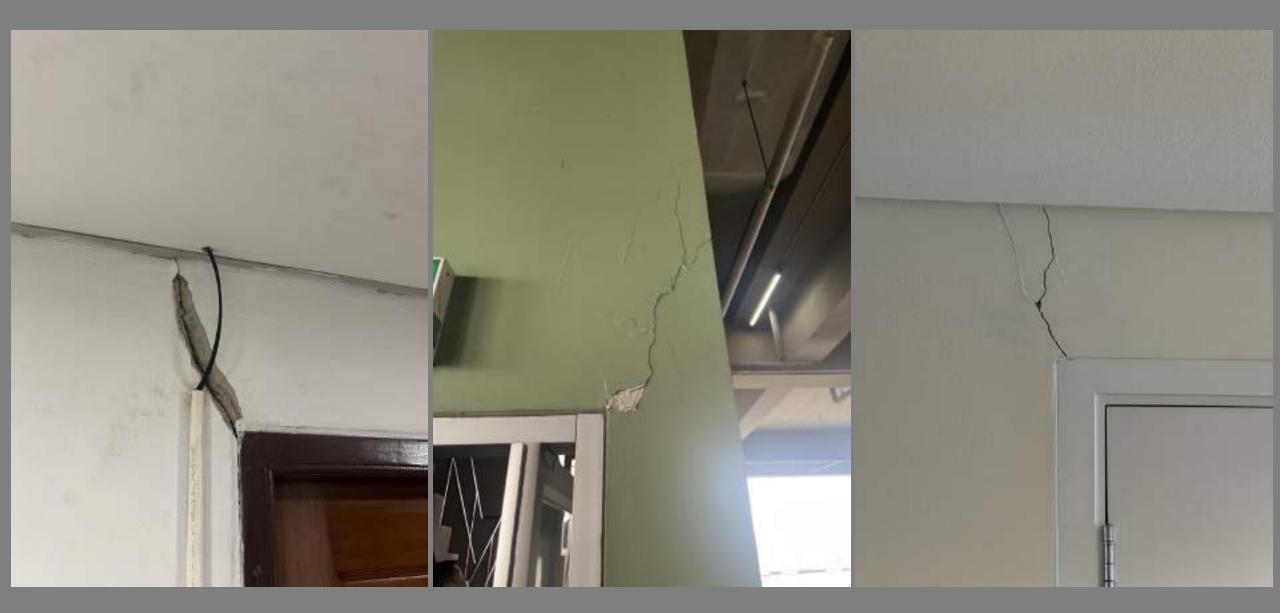
# Door Corner Cracking in Masonry Wall (commonly seen 15/15)

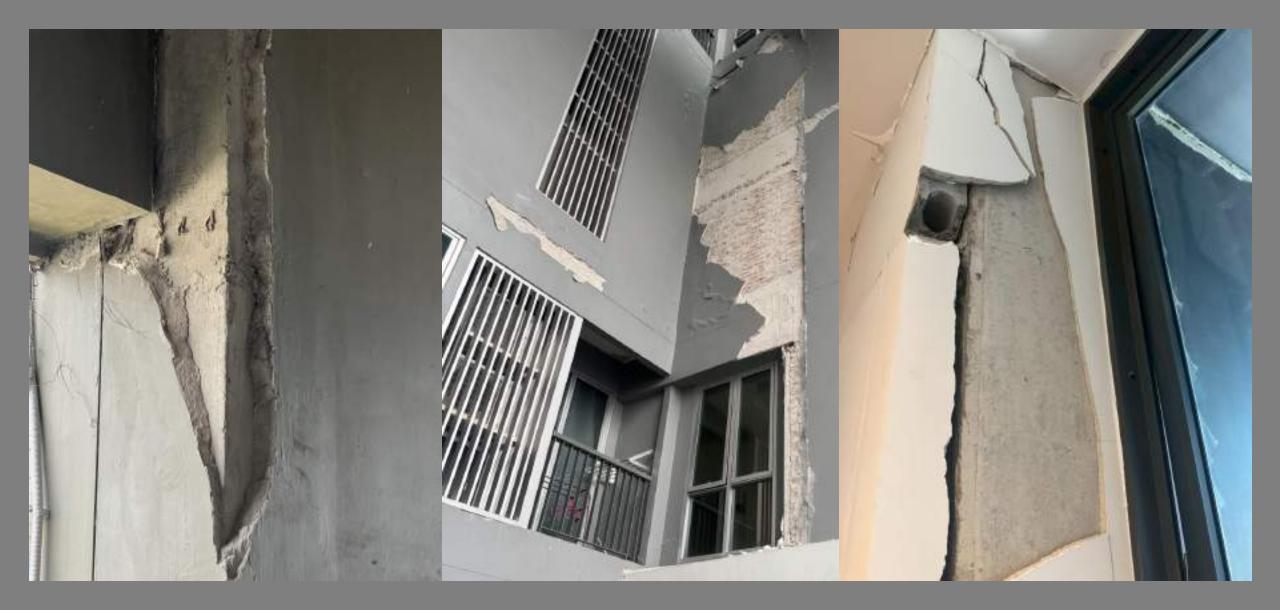
# Spalling of interior and exterior plaster (commonly seen 14/15)

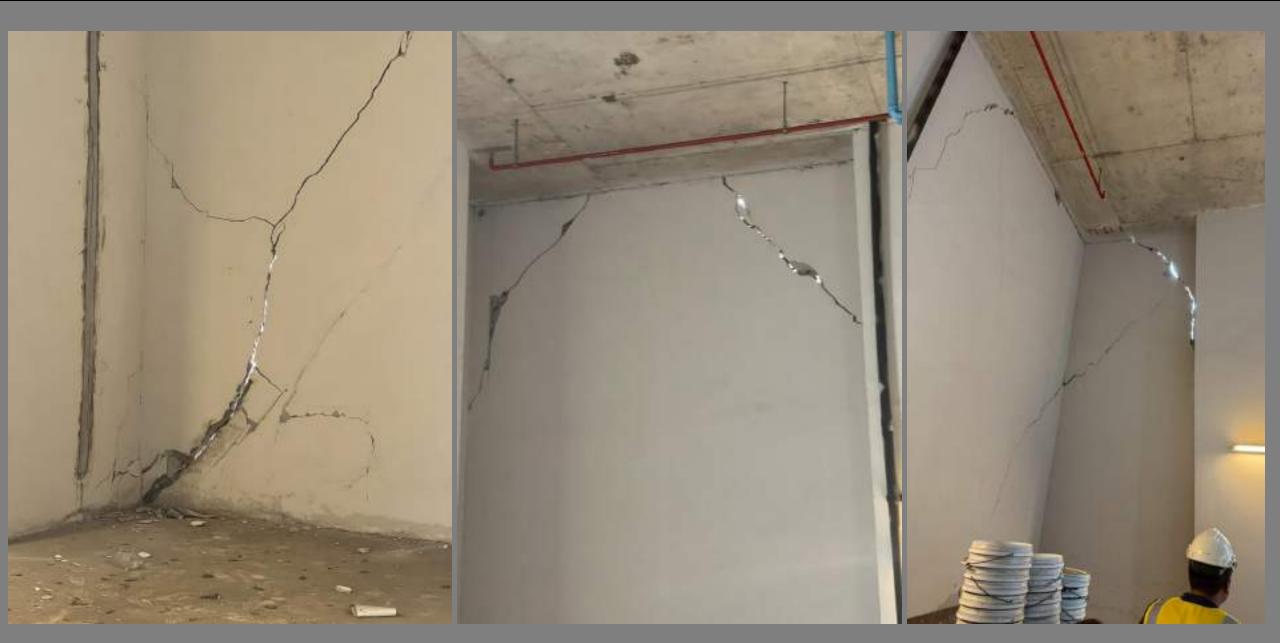
### Severe cracking of masonry wall on both side (rarely seen, 2/15)

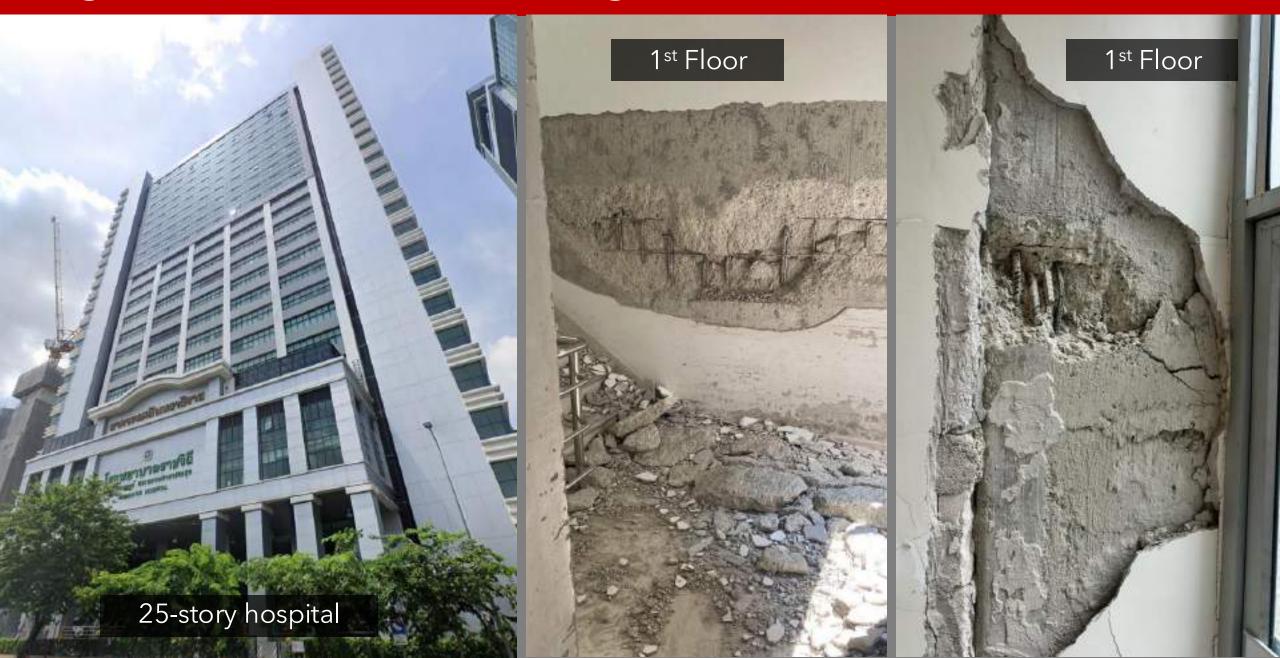
# Significant Structural Damage (25-story, Rajavithi Hospital)

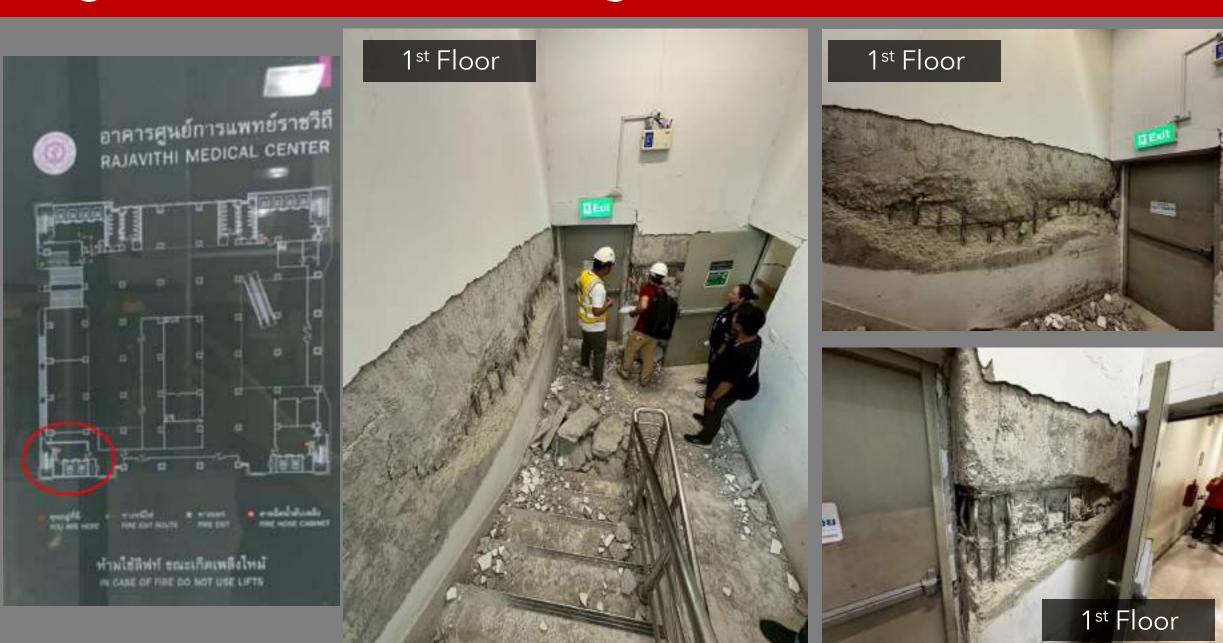
### Significant Structural Damage (25-story, Rajavithi Hospital)

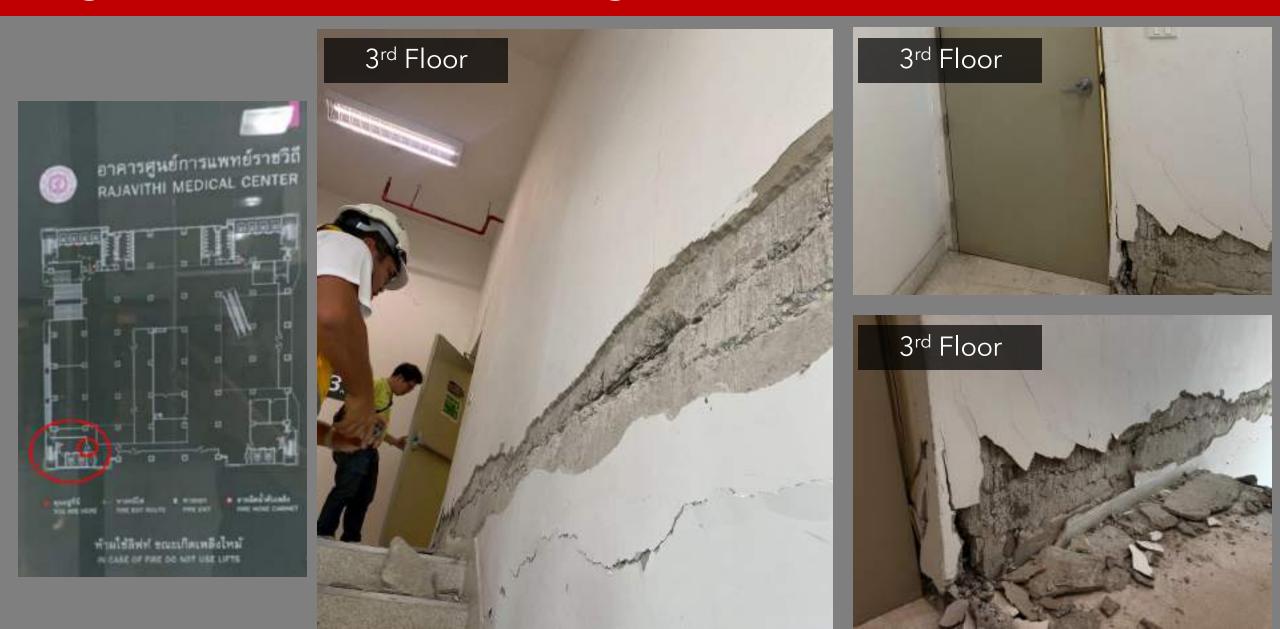
### Significant Structural Damage (25-story, Rajavithi Hospital)

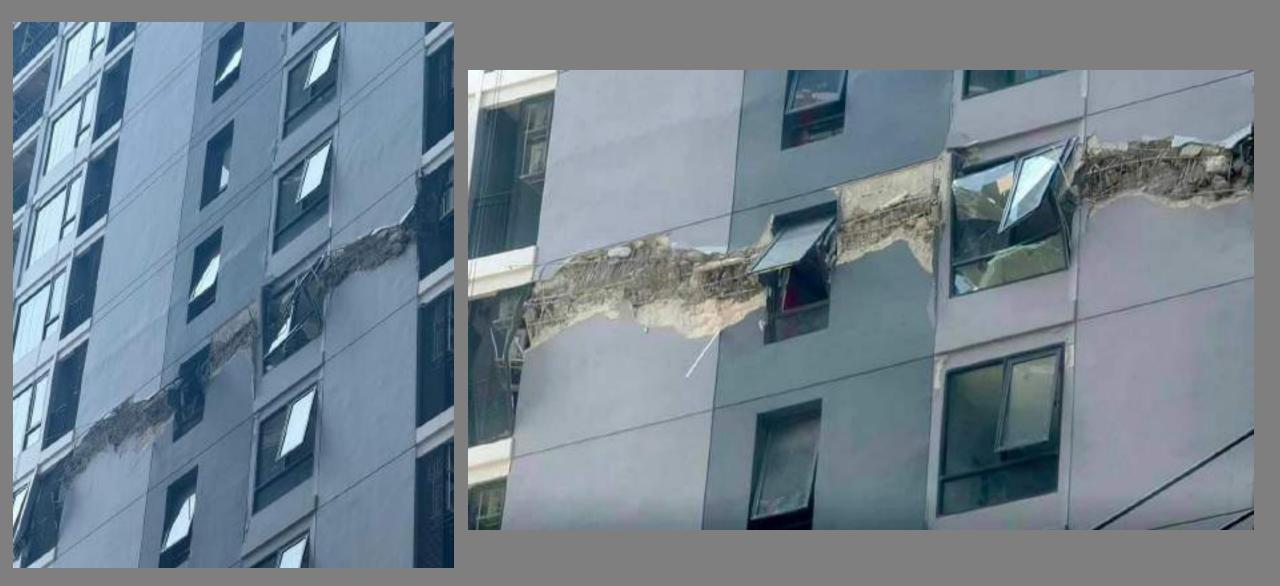
# Significant Structural Damage (Building in Bangkok)

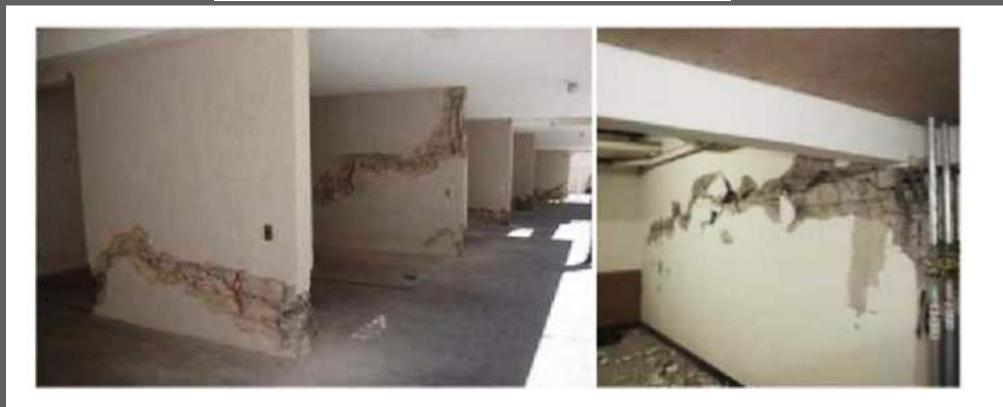
Figure 1. Typical wall damage in the 2010 Chile earthquake.
