### The Bangkok Earthquake and What we learned from it

### Pennung Warnitchai

Professor of Structural Engineering Asian Institute of Technology (AIT)

# M 7.7 - 2025 Mandalay, Burma (Myanmar) Earthquake

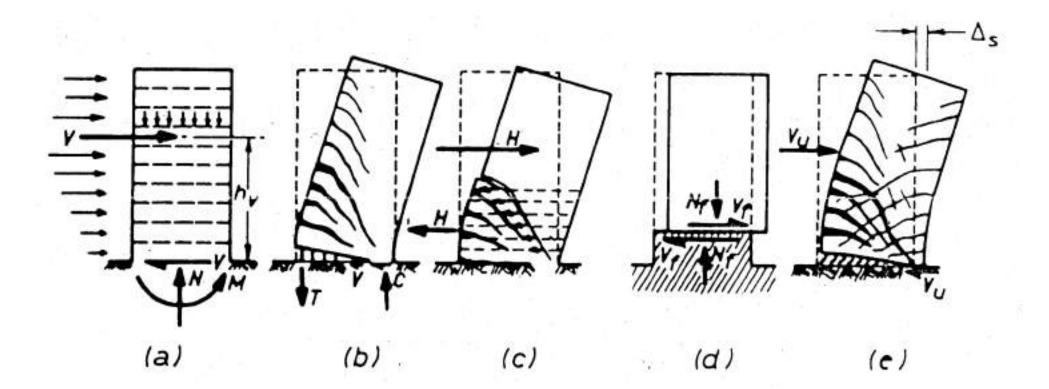
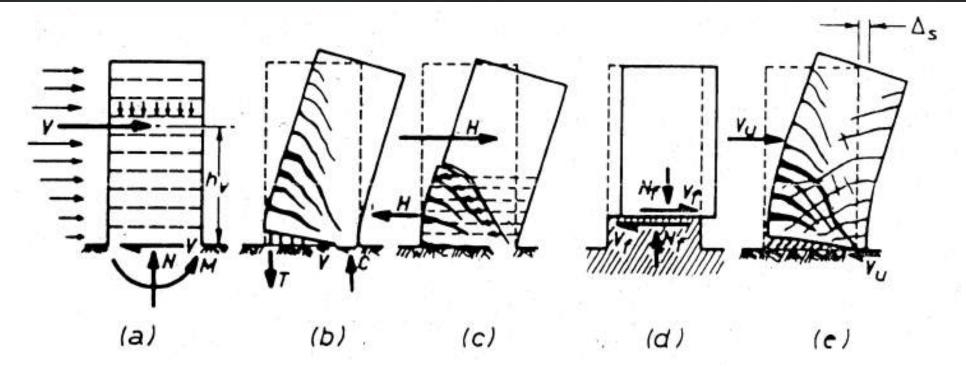
*Failure modes* to be prevented are:

- Diagonal tension failure (c) caused by shear,
- Diagonal compression failure caused by shear,
- Instability of thin walled sections,
- Instability of the principal compression reinforcement,
- Sliding shear along construction joints (d),
- Shear or bond failure along lapped splices or anchorages (b).

A basic requirement for walls to be ductile: **a flexural plastic hinge zone should be formed at the base of the wall**, **and brittle failure mechanisms should not be permitted to occur**.

This is achieved by establishing a desirable hierarchy in the failure mechanics using **capacity design procedures** and by appropriate detailing of the potential plastic hinge region.
